## **The Orchard Tunnel**

**Jonathan Cully & The Society for Old Lucan**

## The Orchard Tunnel, Lucan Village

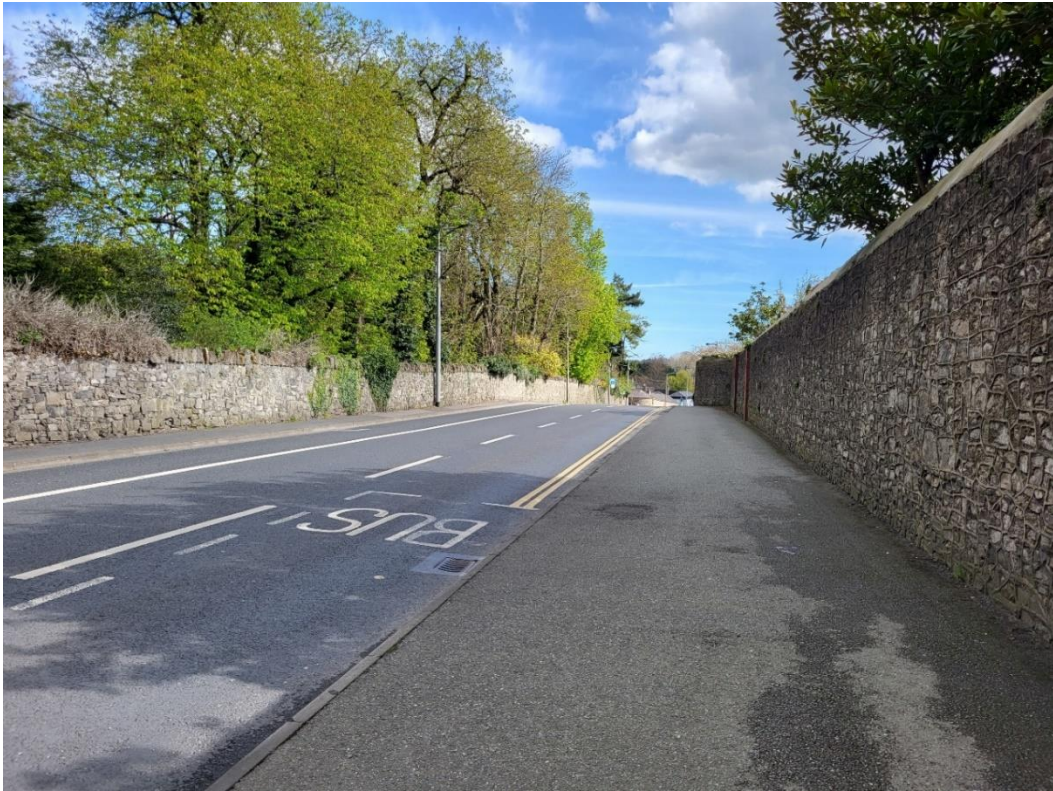
*Figure 1 Looking towards Lucan village, the hump in the Leixlip Road as it passes over the tunnel is evident. Lucan Demesne is located on the left, while its walled garden, now the Orchard Estate, is on the right. The bow-fronted projection that houses the stairs to the tunnel from the orchard is visible on the background. This was once mirrored on the far side of the road.*

Remarkably, many features of the old subterranean passage remain, though the tunnel itself is now blocked, and to some extent partially collapsed. There are three features of the tunnel visible from the Leixlip Road. The first is the hump in the road, which is clearly visible when approaching the tunnel from either direction. The second feature is the large bow-fronted projection in the Orchard boundary wall, which encroaches onto the otherwise wide public path. This projection frames the stairs and archway that lead to the tunnel from the Orchard. The historical Ordnance Survey maps show that this feature was once mirrored on the opposite side of the road in the boundary wall of the Demesne, creating a bottleneck in the road above the tunnel. Having the boundary walls projecting out in a bow on either side of the road was possibly a cost-effective way of reducing the overall length of the tunnel, while also aesthetically framing the entrances on the interior. The projection on the Demesne side, however, has long since been removed, possibly to facilitate the extension of the tram line from Lucan to the Spa Hotel around 1910. Many of the cast-iron posts used to support the trams electrical wires still exist along the Demesne boundary wall. It is also possible that the projection was removed to widen the road and better accommodate ever increasing automobile traffic. Whatever the reason for its removal, the infilled masonry within the section of straightened wall stands in contrast to the older masonry on either side, with straight edges visible at the joints where the bow once was. The bow in the Demesne wall last appears on the 25-inch map of 1897-1913, with subsequent maps showing the Demesne wall as a continuous straight line.

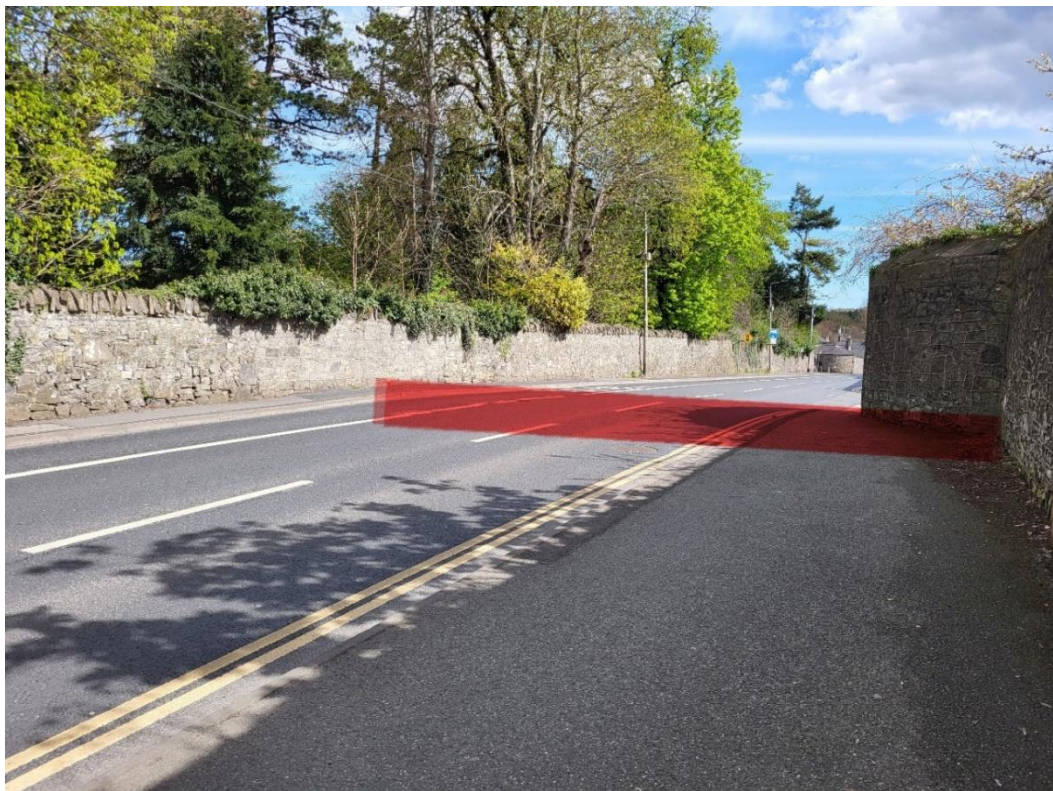
*Figure 2 The line of the tunnel is highlighted in red. the road noticeably slopes down towards Lucan Village after passing the location of the tunnel.*

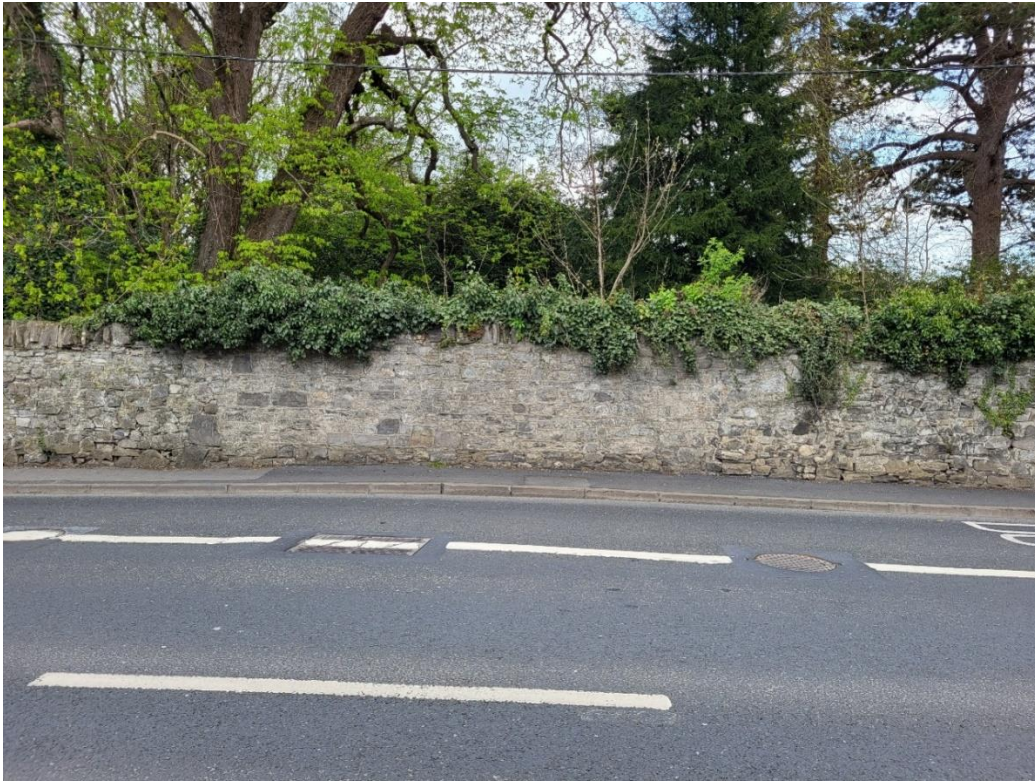
*Figure 3 The boundary wall of the Demesne once had a bow-fronted projection like the one in the Orchard wall, however it was removed, and the boundary wall straightened. Telecommunication services now occupy a section of the tunnel, the access points to which can be seen at the crown of the hump in the middle of the of the road. A manhole to the right shows that the modern sewer system also runs down the middle of the road, cutting through the tunnel.*

The archway in the Orchard on the other hand, remains completely intact. The wide archway measures several feet across, and now features added brickwork with an inset metal door that covers yet another wooden door within. The vibrancy of the later orange brickwork contrasts strikingly with the older 18th century brickwork found in the wall surrounding the cut stone arch. It is plain to see that the Orchard end of the tunnel features a more utilitarian aesthetic, lacking the decorative potholed limestone used to dress its peer across the road. The tunnel still exists to some extent on this side, though it is reliably reported to be in very poor condition and partially collapsed. At most the tunnel cannot extend beyond the intersection of the Sewage system and Telecommunication lines which run along the centre of the Leixlip Road. Indeed, the telecommunications appear to have taken advantage of the void beneath the road as their maintenance access covers are located directly at the intersection with the tunnel.

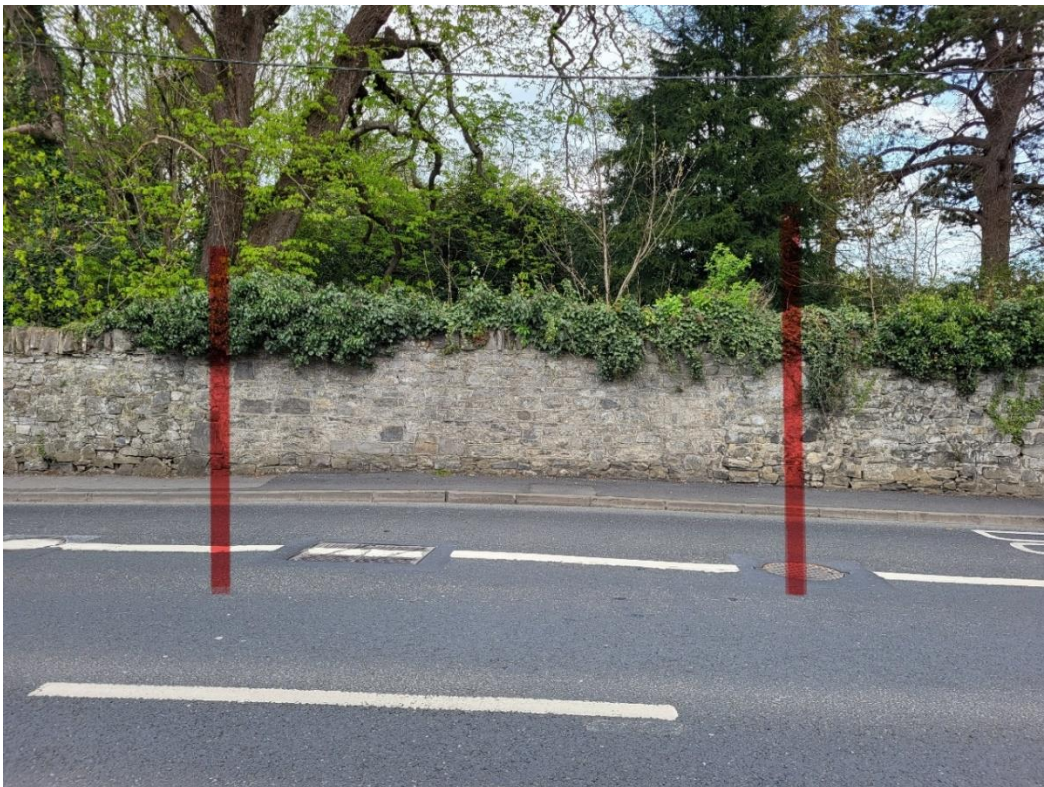
*Figure 4 The section of infilled wall that replaced the original bow-fronted projection in the Demesne boundary wall is indicated by the red lines. The composition of the masonry is noticeably different. Without referencing old maps to see that a projection once existed, one would think that the wall was simply repaired.*

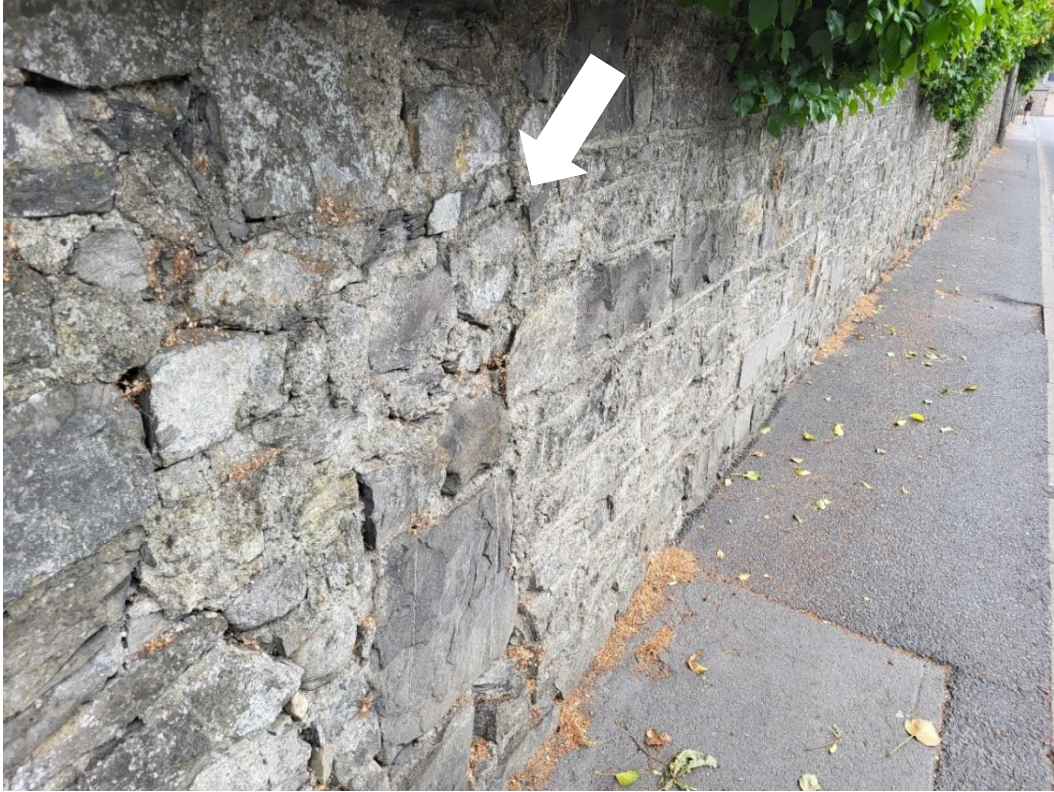
*Figure 5 The seams between the original sections of the Demesne boundary wall on either side of the infilled section can clearly be seen on closer inspection. The random rubble masonry of the original boundary on the left, with the neater blockwork of the infill on the right.*

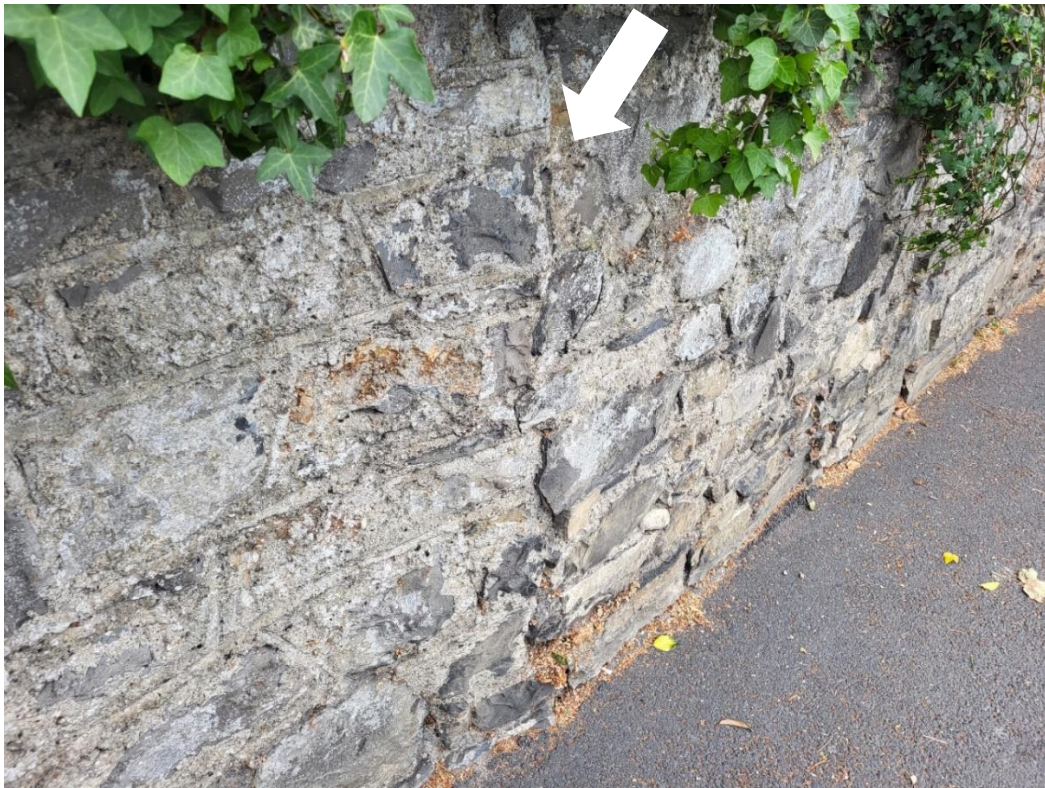
*Figure 6 The random rubble masonry of the original boundary on the right, with the neater blockwork of the infilled section on the left. The seam between the two runs in a straight line down the middle of the wall.*

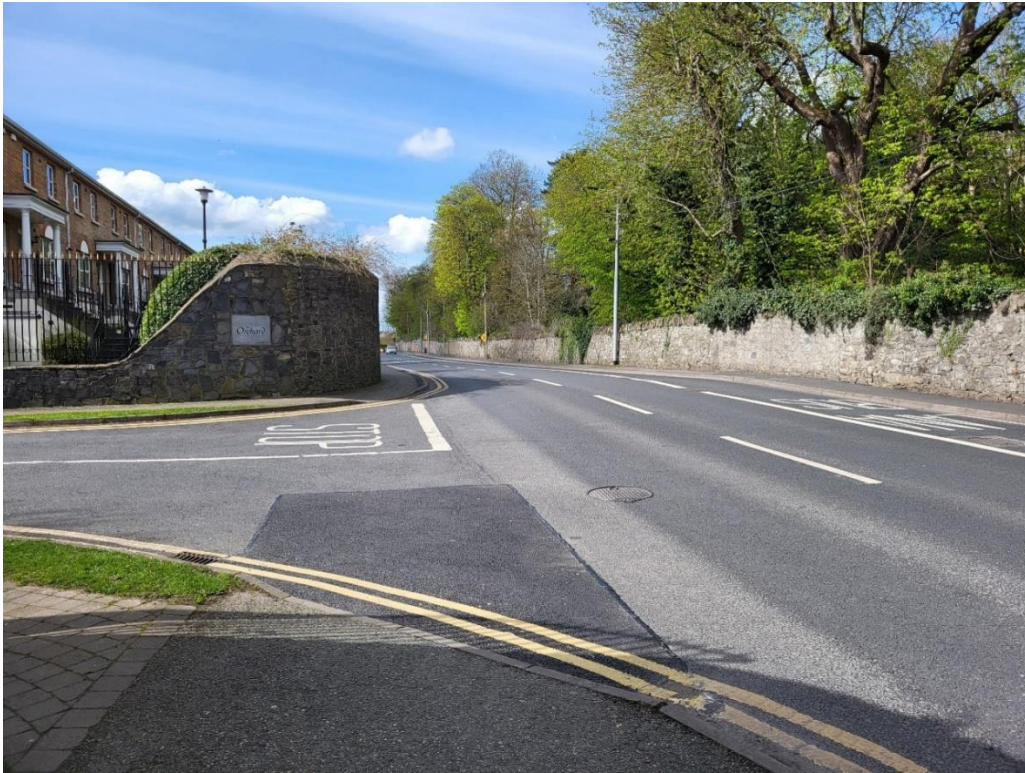
*Figure 7 View of the hump over the tunnel looking away from Lucan Village. The bow-fronted projection in the Orchard wall has been incorporated into the entrance of the walled estate, with a new section of wall with railings following the curve of the original projection. This entrance is new, with the original entrance (hidden from view behind the projection) being blocked up.*

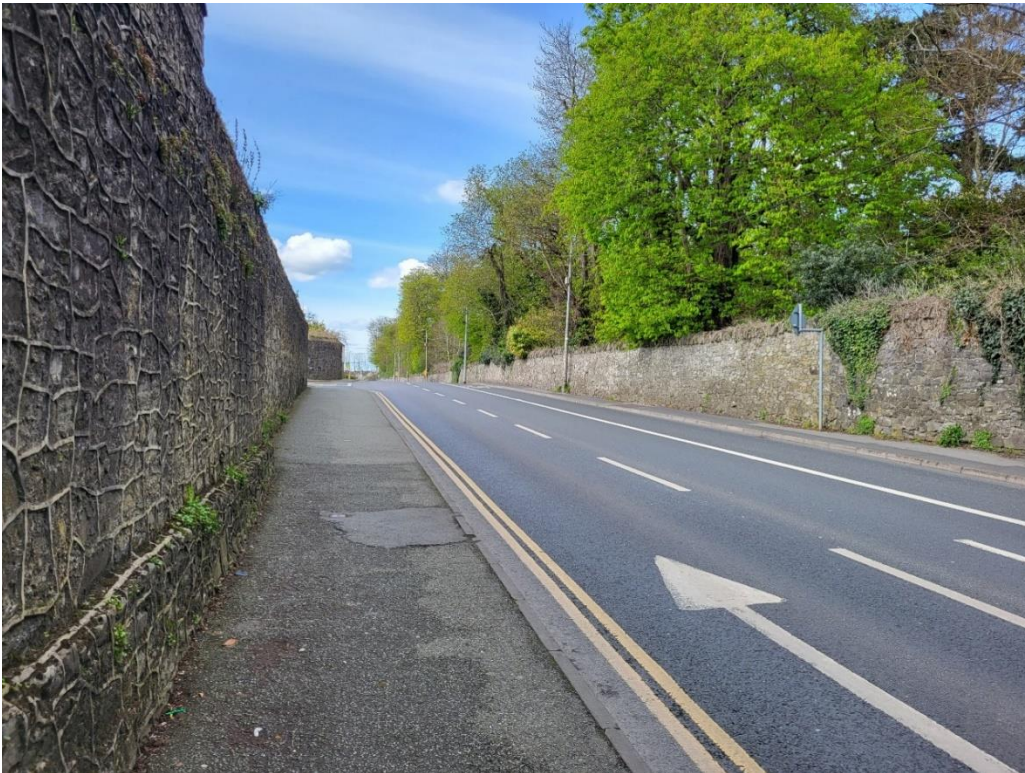
*Figure 8 The hump in the road becomes more evident the closer you are to the Village. The wall of the Orchard on the left are also noticeably higher than that of the Demesne across the road, a deterrent for any would-be orchard thieves.*

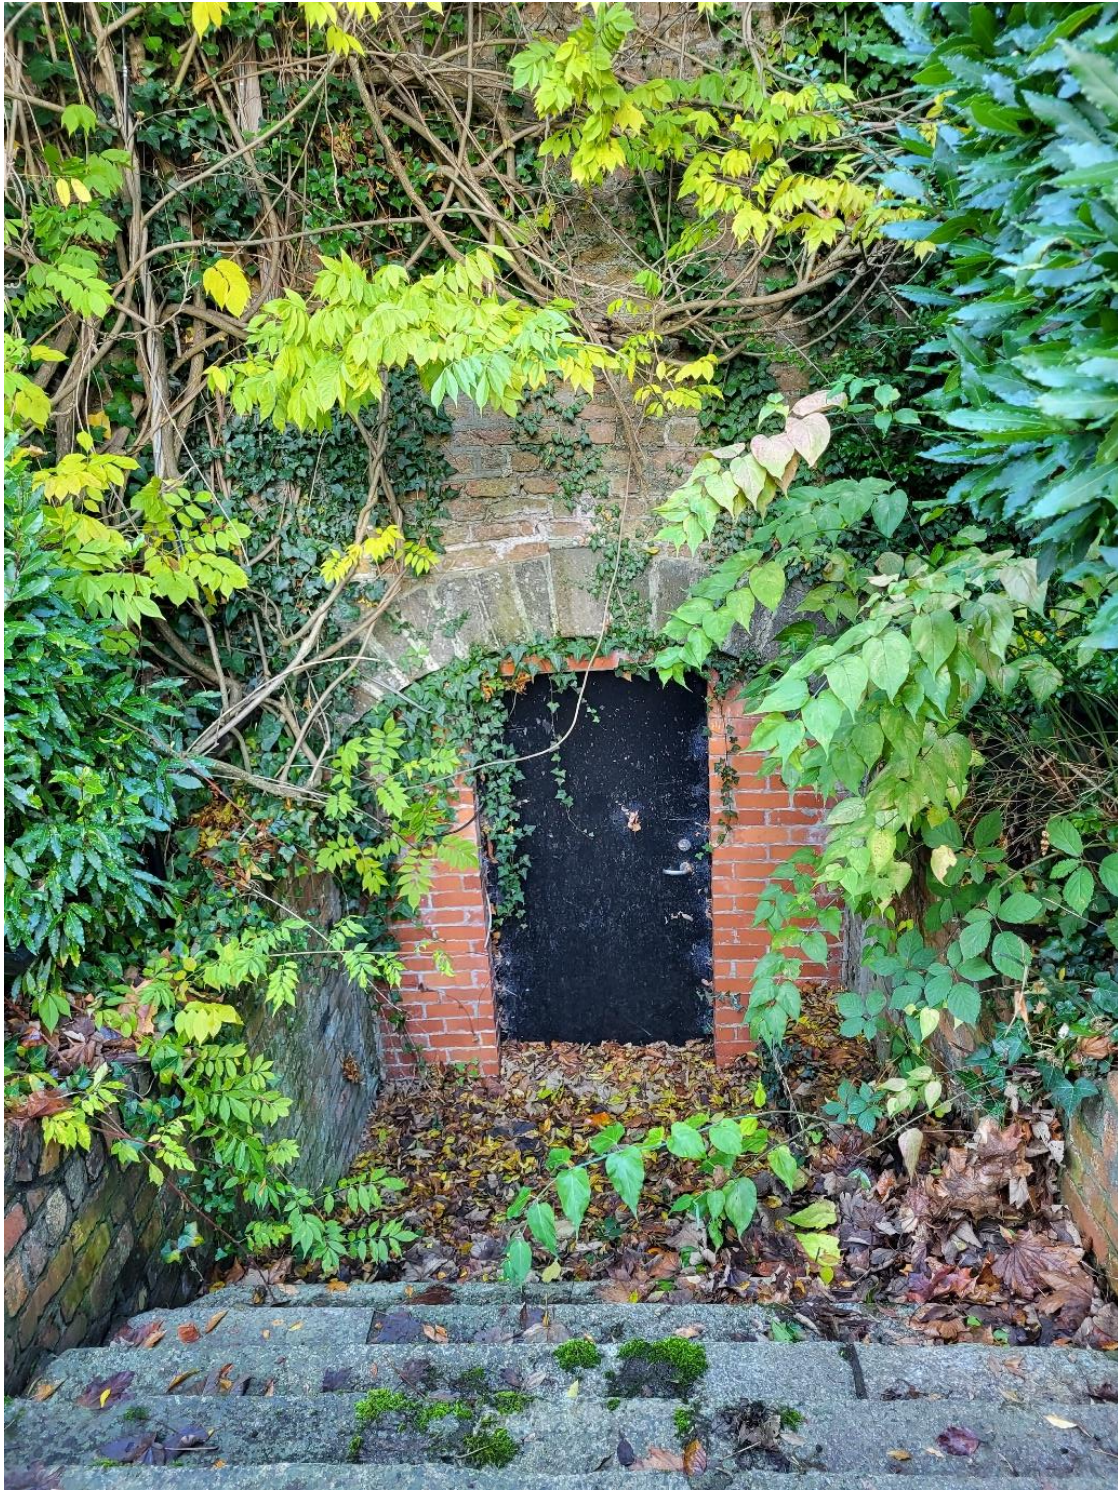
*Figure 9 The original archway to the tunnel, located within the projection of the Orchard wall. Originally a wide, open archway, it was later bricked up with a doorway being inserted to prevent access. The flight of stone steps that lead down to the archway have been preserved. The arch is formed by plain cut stone voussoirs.*

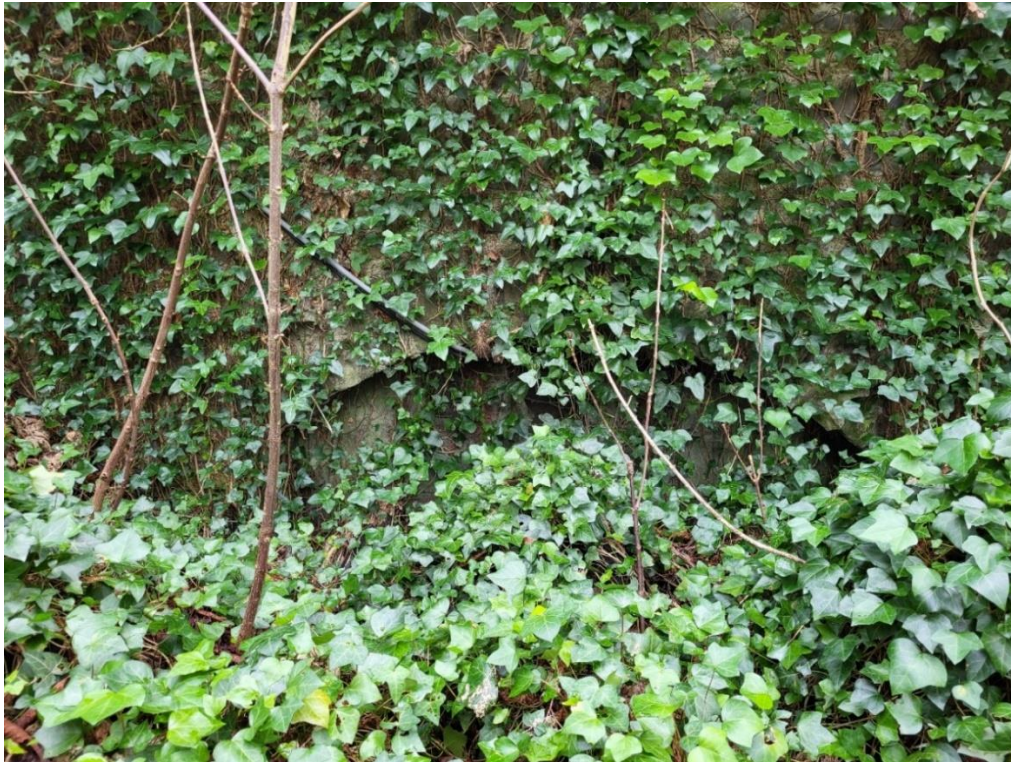
*Figure 10 The archway set within the boundary wall of the Demesne was almost completely obscured, being half buried and covered by overgrowth. Originally set within a bow-fronted projection similar the one on the orchard side, the arch was relocated to its current location when the wall of the Demesne was straightened. This archway was blocked up in the 1930's when the lands of the walled garden where sold, breaking the link which had joined the two for centuries. The use of the tunnel to house telecommunications is highlighted by the thick cable exiting through the top of the tunnel.*

Less visible to the public are the two archways that once granted access to the tunnel, with one in the foundation of the Demesne boundary wall and the other within the bow-fronted projection of the orchard wall. The Demesne archway, like many other features found throughout the estate grounds, is adorned with a naturally rusticated, limestone keystone and voussoirs. Access to the tunnel from the Demesne is now entirely blocked off, with only the top of the arch visible above ground level. The 1897-1913 25-inch map shows steps leading down to the entrance, which was once located within a bowed projection. It appears that the tunnel was extended accordingly when the projection in the boundary wall was removed, with the original masonry of the archway being relocated into its present location within the new section of straightened wall. Desmond Guinness noted that the tunnel was blocked-up on the Demesne side during the 1930's after the grounds of the orchard were sold.

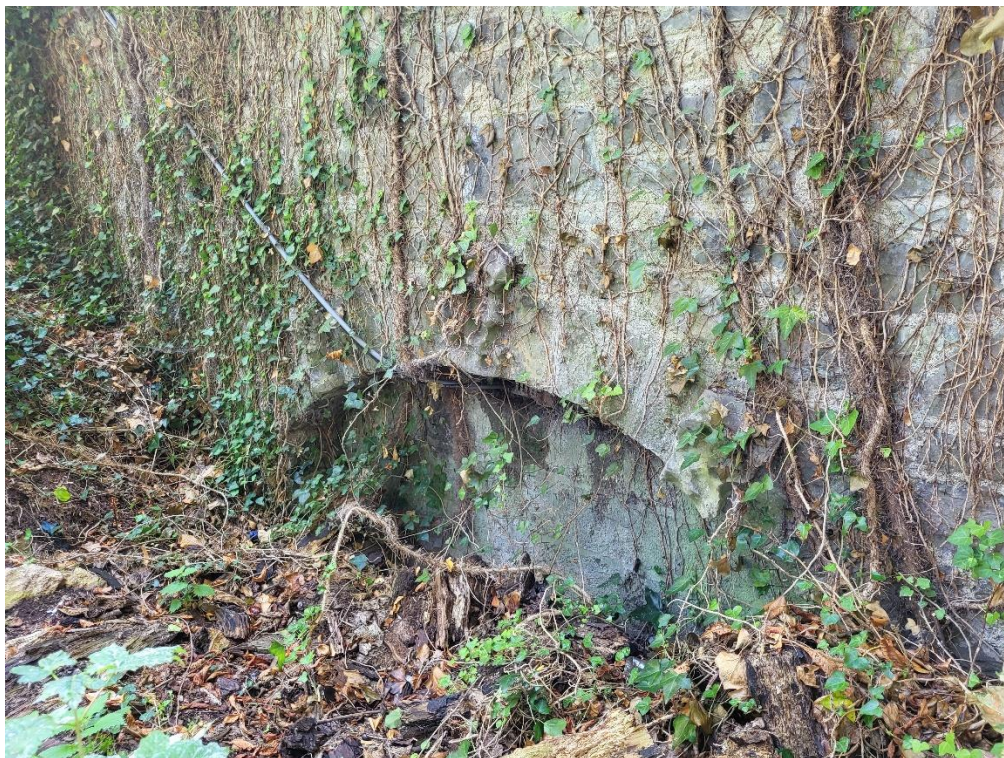
*Figure 11 Since the acquisition of Lucan House by South Dublin County Council, the overgrowth along the inside face of the Demesne boundary wall has been cleared, revealing the tunnel entrance once more. Photograph taken on the 7<sup>th</sup> of September 2024.*

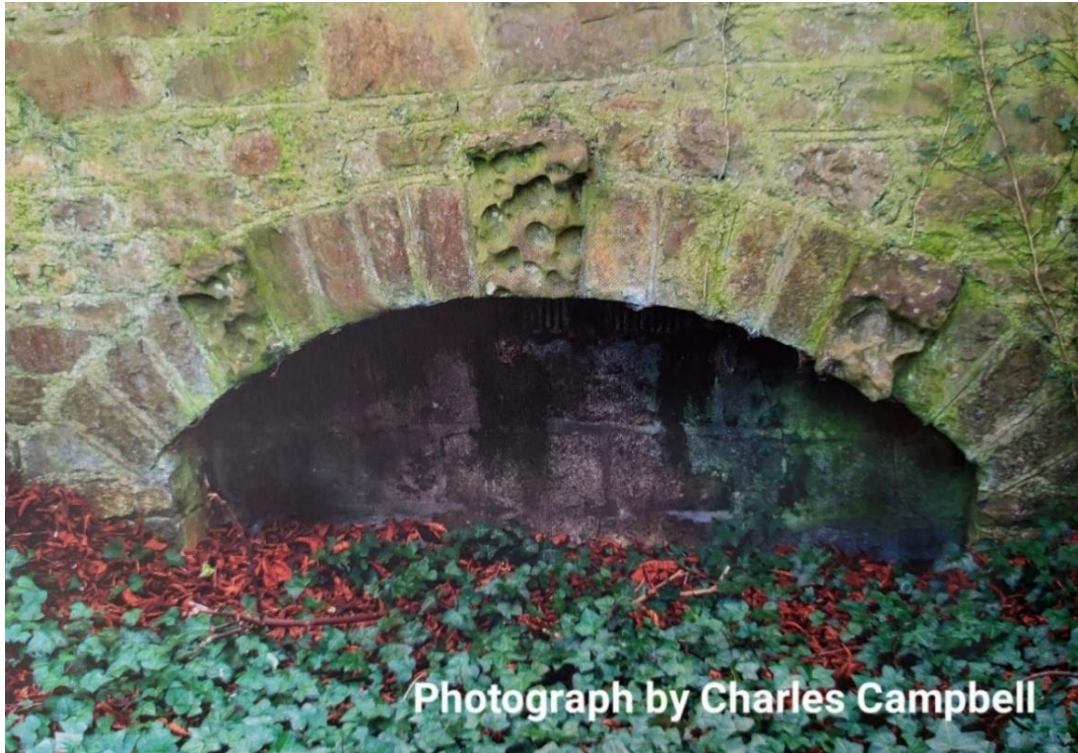
Figure 12 A photograph of the Demesne archway in Desmond Guinness' book on Lucan House shows the top section of the blocked-up archway free of overgrowth. The keystone and two of the Voussoirs are cut from naturally rusticated limestone, a feature which is found throughout the grounds of the Demesne and dating to the 18<sup>th</sup> century. Source: Lucan House by Desmond Guinness.

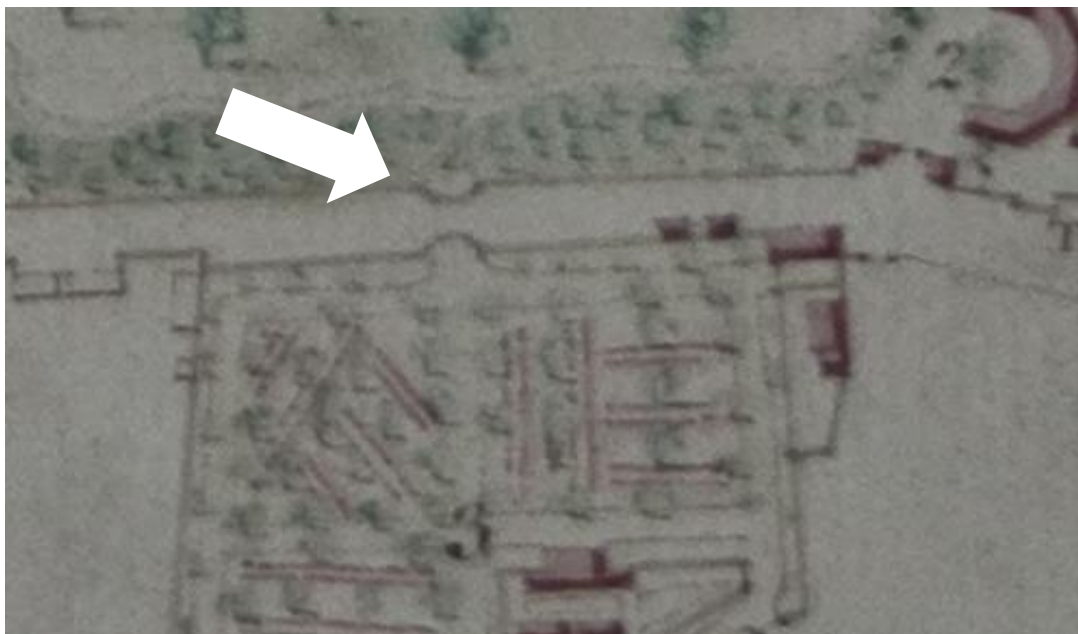
Figure 13 Bernard Scalé's 1772 Map of Lucan clearly shows projections in the walls of the Demesne and Orchard on either side of the road. Scalé's map represents the first recorded indication that a tunnel between the Demesne and the Walled Garden may exist. A trail can be seen branching off from the main path in the Demesne and leading towards the projection in the Demesne boundary. On the top right the original, and then principal, gateway to Lucan Castle can be seen, with the stable and coach house just inside the gate. Source: South Dublin Libraries.

One of the oldest maps of Lucan, Bernard Scalé's 1772 map, makes no direct reference to the passage, though the elements that comprised it are clear to see, with projections in the boundary walls visible on either side of the Leixlip Road. Trails within the Demesne can

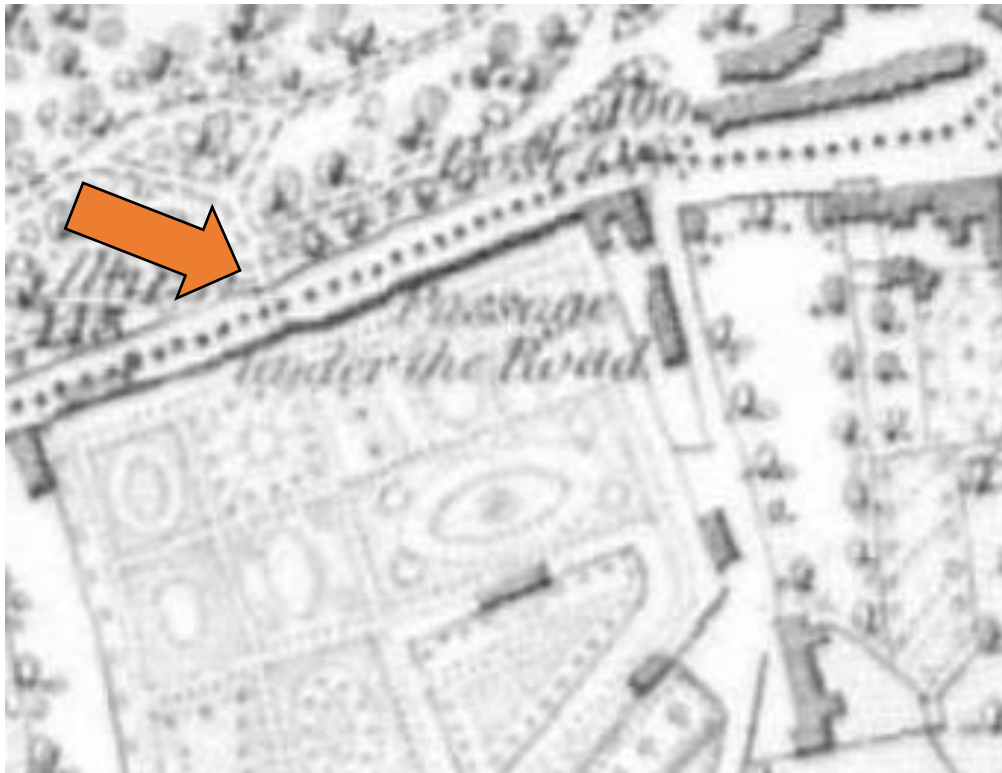
Figure 14 The projections in both boundary walls can be seen on the First Edition 6-Inch Ordnance Survey map of 1829-41. The tunnel is referenced for the first time with "Passage under the Road" noted just below. The trail from the grounds of the Demesne clearly continues through from the tunnel into the Orchard. The gateway noted in the map above is now a secondary entrance to the grounds of the Demesne with the original lodge noticeably extended to accommodate new servant quarters. Source: Ordnance Survey Ireland.

be seen leading to the location of the tunnel, only to disappear into the boundary wall and re-emerge on the far side within the orchard. This trait is continued on all subsequent maps; with only some maps making a direct reference to the tunnel. The First Edition 6-Inch map of 1829-41 references a "*passage under the road*", while the Last Edition 6-Inch map of the 1930's simply notes "*Subway*". Ordnance Survey maps used by the Dublin County Council water inspector still referenced the presence of the "*Subway*" as late as the 1970's-80's; it is likely that this remains the case on current issue Ordnance Survey maps.

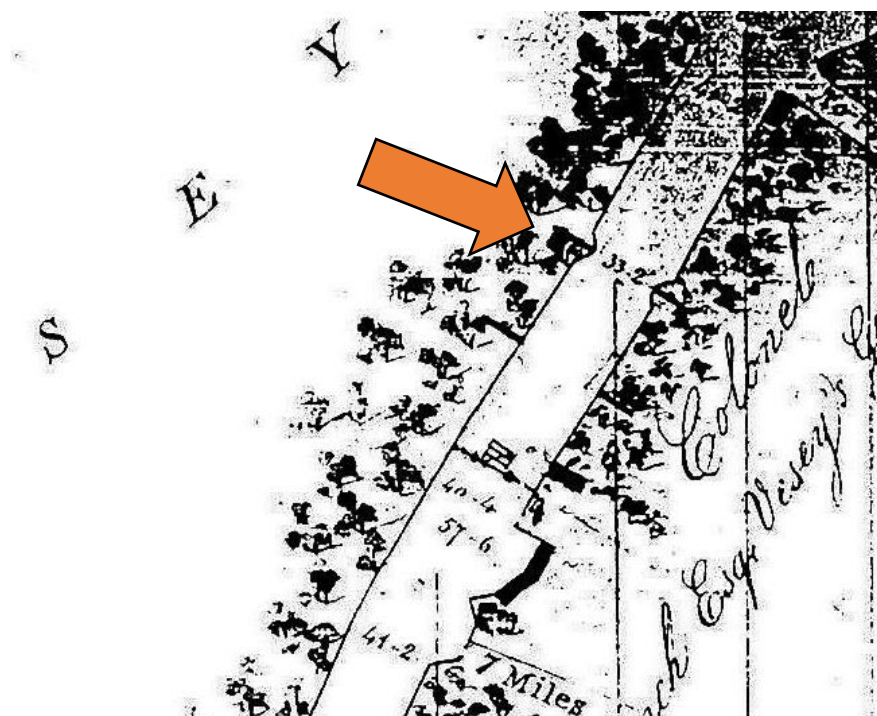
Figure 15 Turnpike map of the road from Lucan to Leixlip, with the protrusions in the boundary walls highlighted. The Lucan turnpike gate can be seen on the road just below the point of the tunnel. While it might have seemed more practical to have the turnpike gate located at the bottleneck created by the tunnel protrusions, it would have caused great disruption to have fully laden carts stop at the top of the hill created by the tunnel, as horses would have found it difficult to start on such a hill once the toll had been paid and the gate opened.

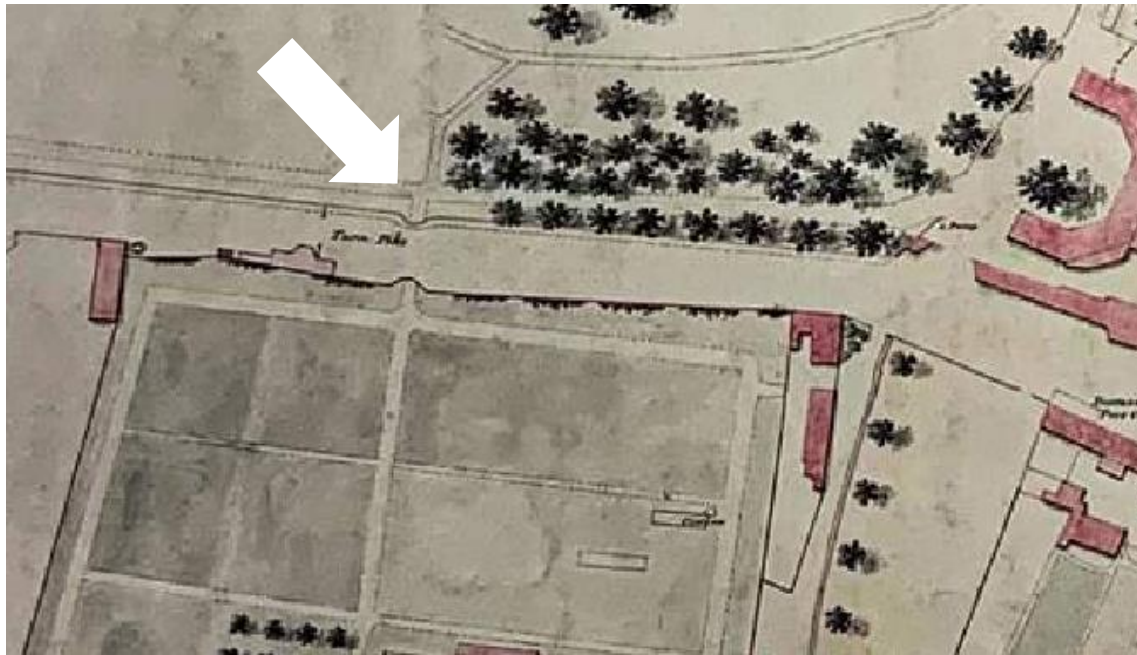
Figure 16 The 1830's Ordnance Survey Map of the Parish of Lucan clearly shows the protrusions in the boundary walls, as well as the nearby Turnpike noted on the above map. No evidence of the turnpike structure now remains. Source: South Dublin Libraries.

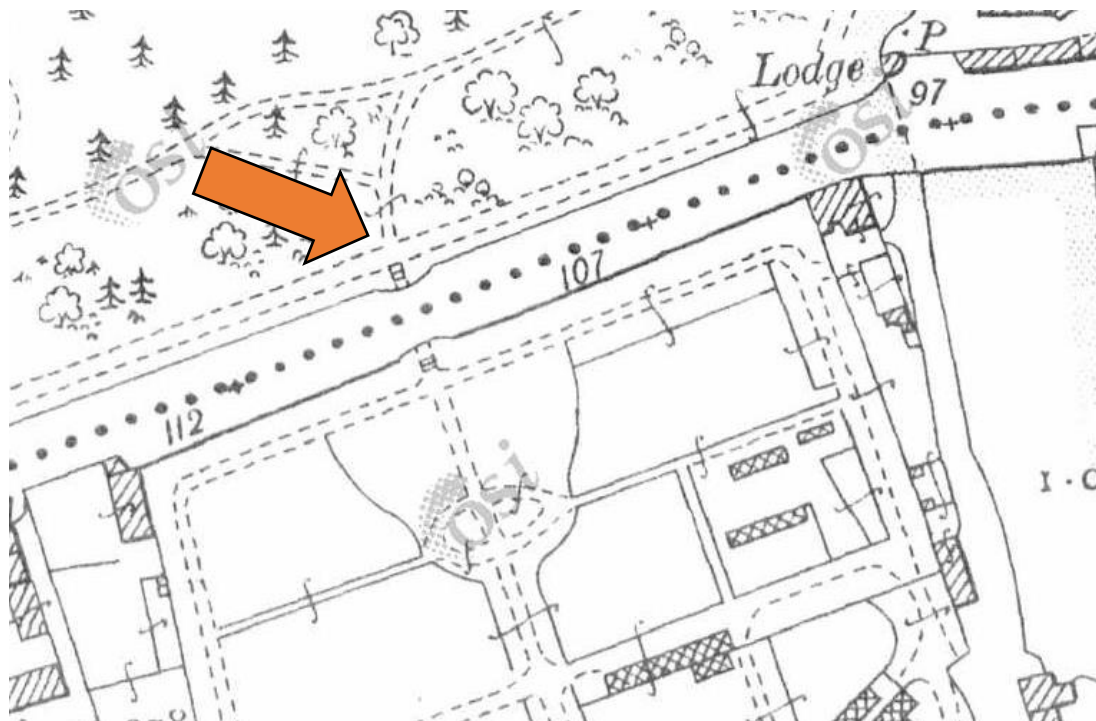
Figure 17 1897-1913 25-Inch Ordnance Survey Map clearly shows the paths leading to and from the tunnel, along with the protrusions of both boundary walls. The entrance to the tunnel from the grounds of the Demesne is shown to have had steps like the ones that remain on the Orchard side. Source: Ordnance Survey Ireland.
